BACKPLATES WITH RETROREFLECTIVE BORDERS

WHAT IS THE COUNTERMEASURE?

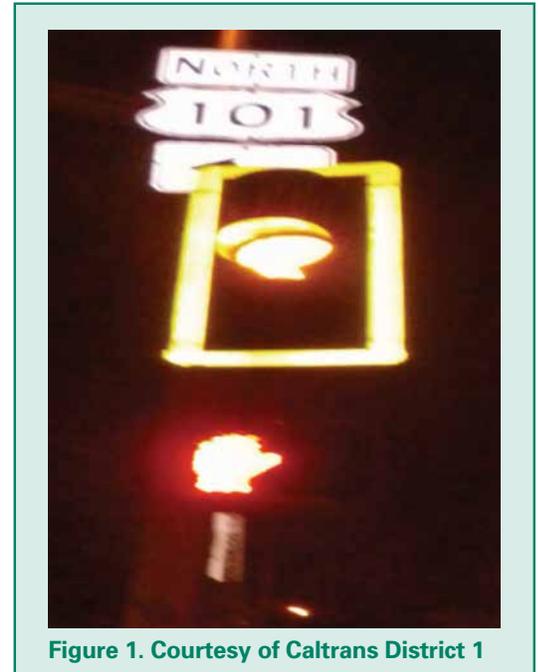
Figure 1. Courtesy of Caltrans District 1

U.S. 101 NB @ R Street, Eureka, CA (February 2013)

On the state system, District 1 has been using this treatment since February 2013 on U.S. 101. Preliminary crash data shows performance better than the expected crash reduction. It is unclear at the local agency level how much retroreflective backplates has been used. Agencies are encouraged to share their experiences with the FHWA Division Office.
